White Paper

Report ID: 2879859

Institution: Montpelier Foundation

Introduction

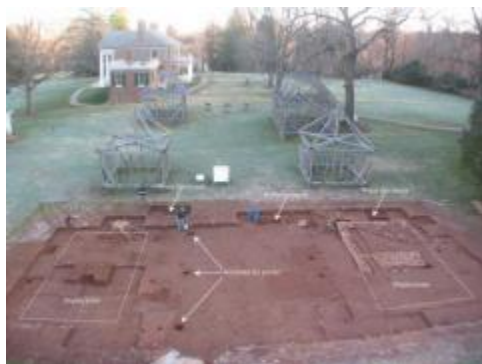
The South Yard is a site of homes of the enslaved house servants at the mansion. Archaeological excavations of these homes revealed these structures to have wooden floors, brick or stone chimneys, glazed windows, and to be framed structures. As such, these structures were a far cry from the crude log cabins that most slaves (and for that matter most folks in the American South) lived in. These homes created a neat village type appearance that was meant to be seen from the mansion--and as they were within the formal grounds of the Madison's home, meant to be seen. Rather

than presenting a better quality of life, residents of these homes would be under the constant scrutiny of the main house, had raised wooden floors that would left in drafts, and not have large amounts of yard space for their daily activities. In addition, activities in this yard space (such as the smoke houses and barbecue trench) were directed more towards the conveniences of the Madisons rather than the families living in this space. The contrast to these homes can be seen in the neighboring structure lived in by Granny Millie. Today the South Yard is "ghosted" with timber-frame outlines to show the size and location of the homes and buildings that were once here. For more information on this site, see the [end of season blog](#).

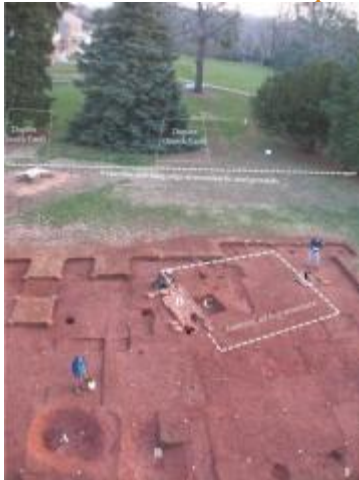
Stable Yard--Granny Millie's Home

The Stable Quarter (aka Granny Milly's cabin) was occupied by skilled artisans who either worked in the stable or the garden) In contrast, the neighboring structure, the quarter located in the adjacent Stable Yard, was a more tradition log dwelling with a stick and mud chimney, at-grade hearth and evidence for clay floors. This structure was outside of the formal grounds of the mansion and located within the stable yard and craft complex—an area between the mansion formal grounds and the larger farm complex. Its construction using materials requiring little refinement (hewn logs and clay) was more typical of enslaved homes across the Piedmont (Finch 1833). This structure also had a sub-floor pit that would have allowed the residents to store sweet potatoes through the winter--no such storage pits were located in the homes in the South Yard. Today the Stable Quarter is represented by a log "ghost" structure and serves as a comparison to those buildings in the South Yard. For more information on this site, see our [blog](#).

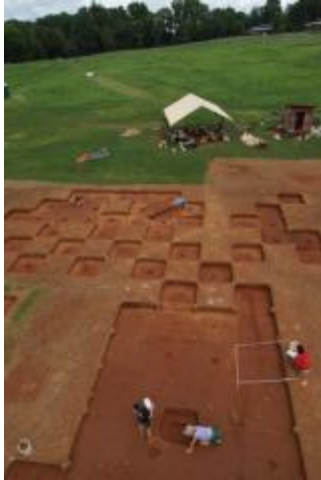
[Field Quarter Homes](#)

The field quarter is located in the fields down the hill from the visitor center parking lot. Archaeological surveys and excavations revealed this area to contain the remains of the Madison-era farm complex—consisting of several slave quarters, barns, work areas, and an overseer’s house. During the 2012-2013 season, archaeologist located and excavated the remains of three homes for enslaved field workers. Based on the finds from these digs, these homes were log structures with clay floors, stick and mud chimneys, and very basic furnishings. In contrast to the stable quarter, there were no brick hearths nor evidence for glazed windows—these were basic structures where the enslaved families’ ingenuity and community connections provided means for shelter. In fact the only archaeological evidence for the structural locations came from the presence of sub-floor pits where families stored root crops. Our near terms plans for interpreting these homes consist of interpretive signs. What is exciting about this work and living complex is that it represents where the majority of the enslaved community lived and is very accessible from the visitor center (walking distance from visitors’ cars is closer to this area than to the mansion). We will be ghosting this structure in 2015 during our next Log Cabin Workshop For a brief summary of this site, see the [following blog](#).
